HOLIDAY VILLA HOTEL SUBANG - NEW CANOPY INSTALLATION AT VICTORIAN BALLROOM GARDEN SITE & SIDE WALK AREA EXISTING SITE CONDITION

RIGHT WAY INDUSTRIAL (MALAYSIA) SDN BHD – DEFECTIVE METAL ROOF AT BLOCK G & H, R.C. ROOF AT BLOCK A EXISTING SITE CONDITION

KELAB TAMAN PERDANA DIRAJA KUALA LUMPUR- INSTALLATION OF NEW WATER TANK EXISTING SITE CONDITION

KELAB TAMAN PERDANA DIRAJA KUALA LUMPUR- CAR PARK BASEMENT B2 C.I. PIPING SYSTEM EXISTING SITE CONDITION

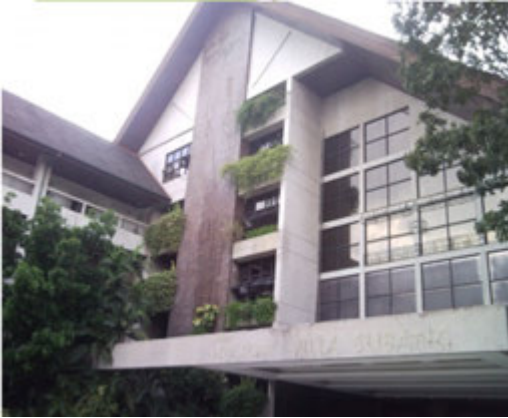
Photo 1
Front entrance at Holiday Villa Hotel & Resorts Subang View

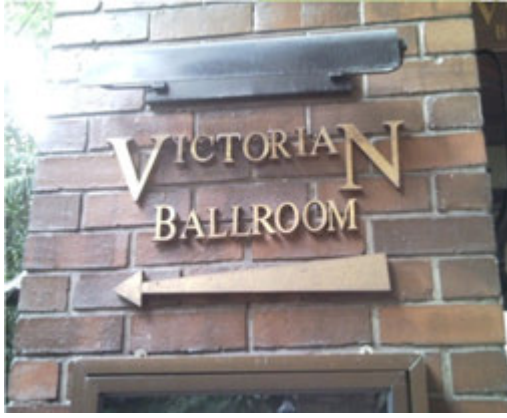
Photo 2
Victoria N Ballroom polycarbonate skylight defective view

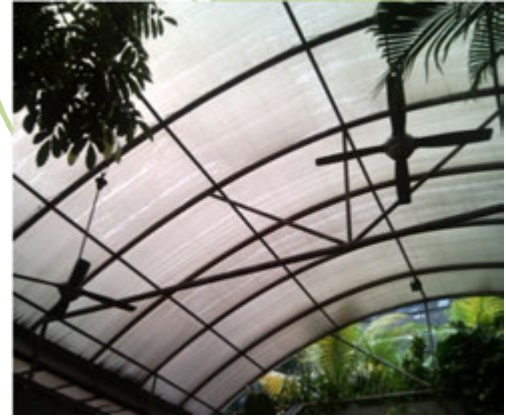
Photo 3
General view of Garden Dome Site of defective polycarbonate skylight

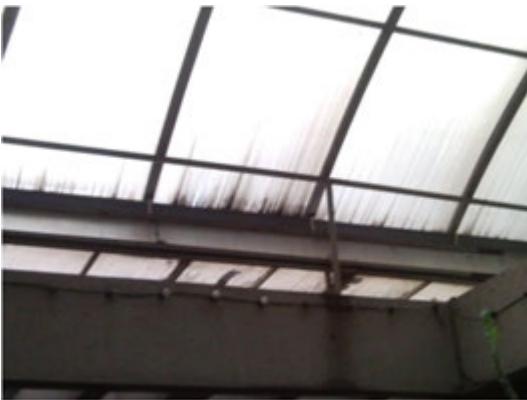
Photo 4
Side view of defective polycarbonate skylight view

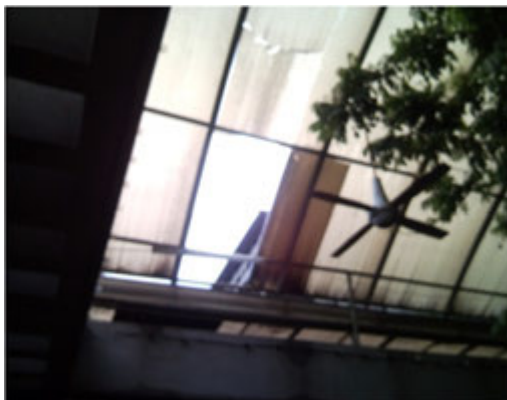
Photo 5
cracked / defective polycarbonate skylight view at garden dome area

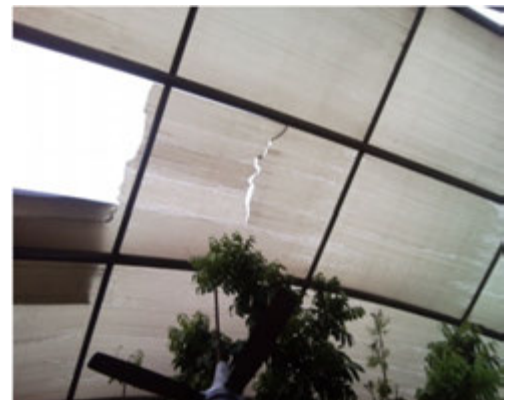
Photo 9
Garden Dome site cracked polycarbonate view

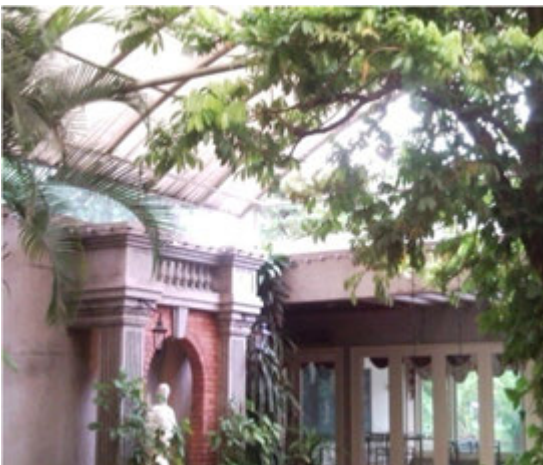
Photo 7
Another view of garden dome site defective polycarbonate skylight view

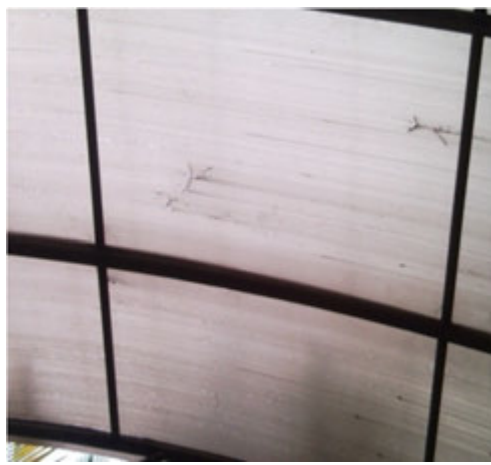
Photo 8
Top view of defective polycarbonate skylight at garden dome site

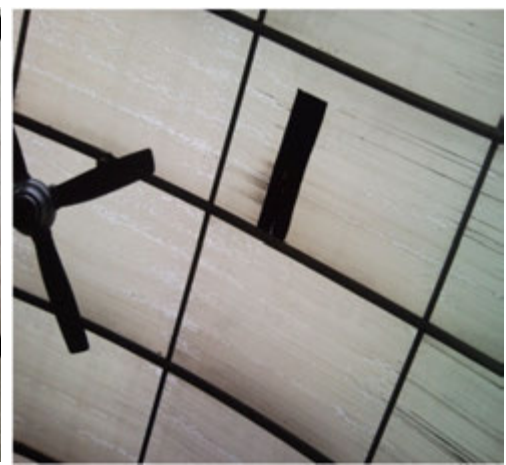
Photo 6
Another view of defective polycarbonate skylight view

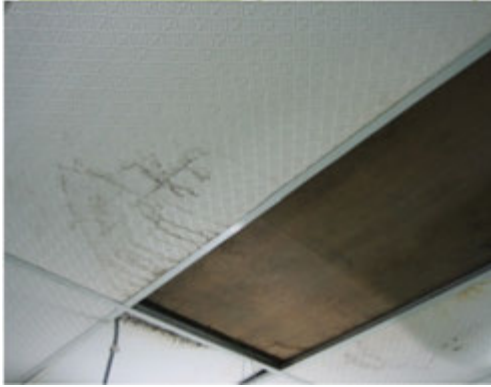
PHOTO 1
Ceiling water stained from metal roof leakage view

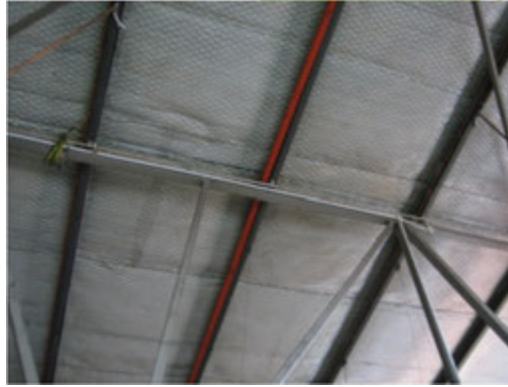
PHOTO 2
Water stained From above metal roof defective view

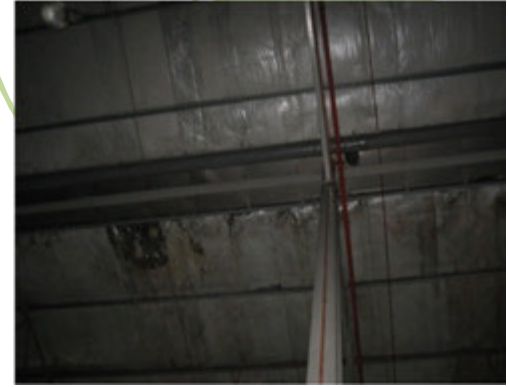
PHOTO 3
Another view of ceiling water stained from metal roof leakage

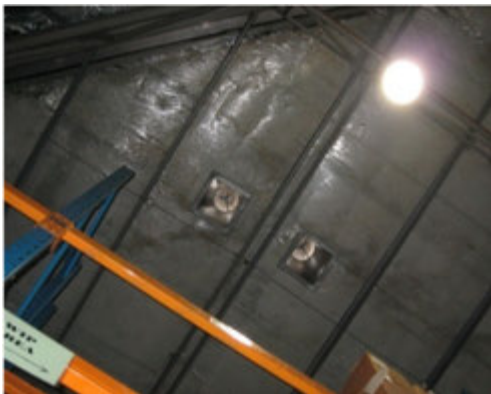
PHOTO 4
Below view of ceiling water stained from metal roof leakage

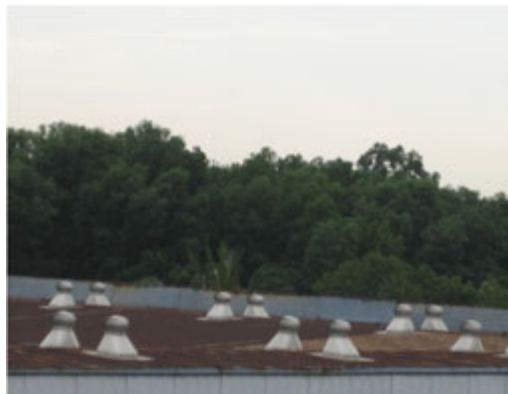
PHOTO 5
Top view of defective metal roofing

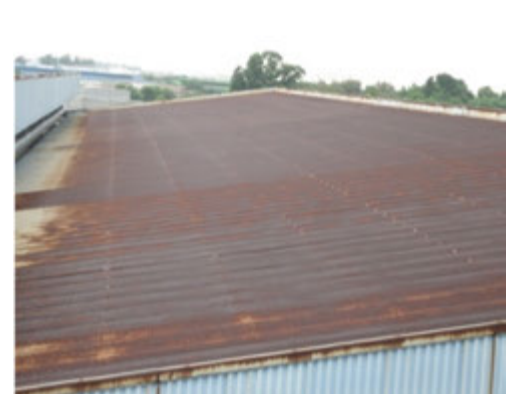
PHOTO 6
Another view of defective metal roof

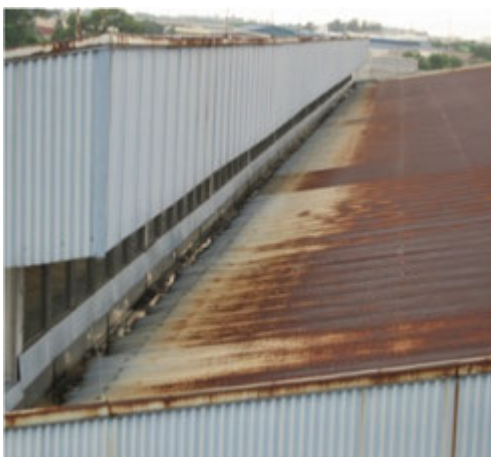
PHOTO 7
Ceiling water stained from metal roof leakage view

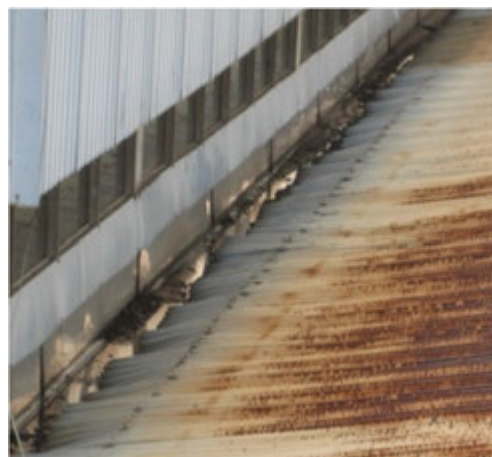
PHOTO 8
Water stained from above metal roof defective view

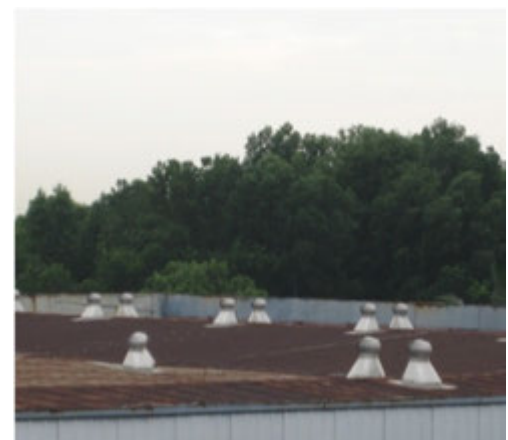
PHOTO 9
Side view defective metal roof

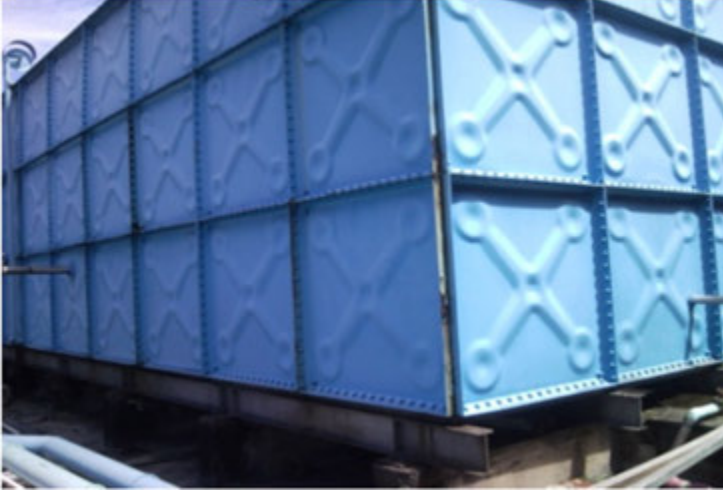
Photo 1
Front elevation of water tank view

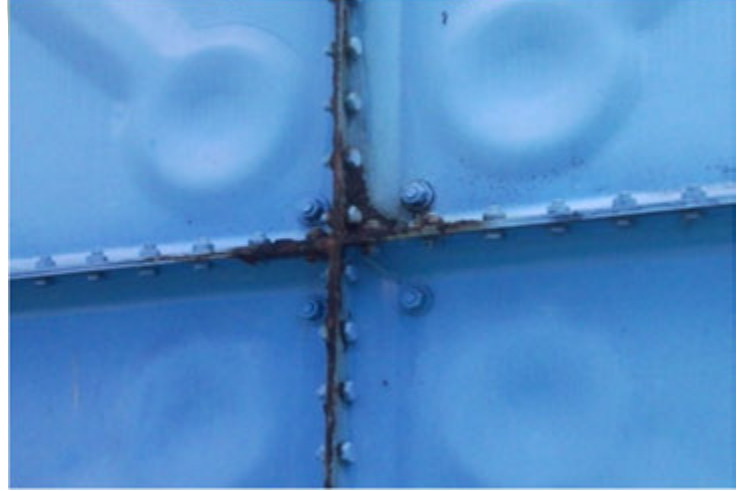
Photo 2
Corroded exterior water tank view

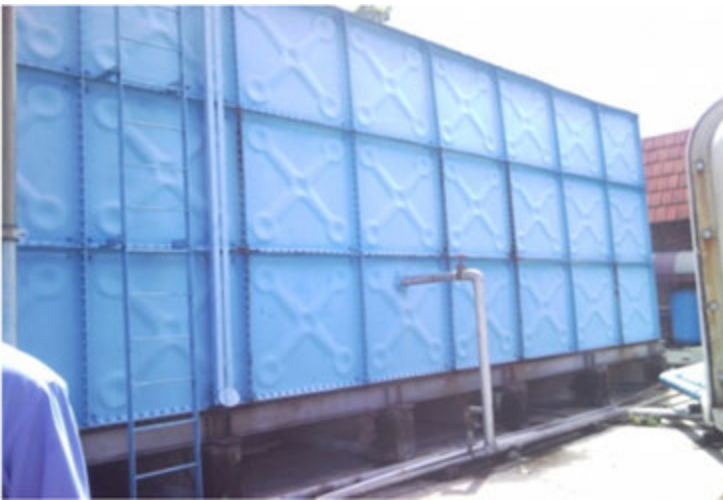
Photo 3
Side elevation of water tank view

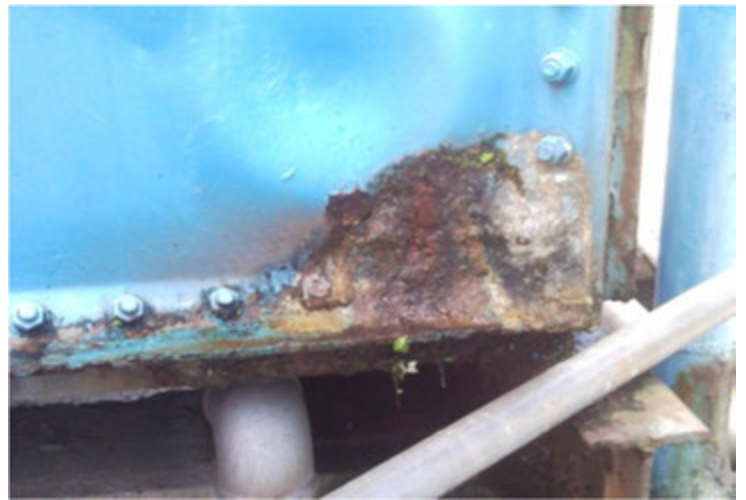
Photo 4
Another view of existing corroded and leakage water tank view

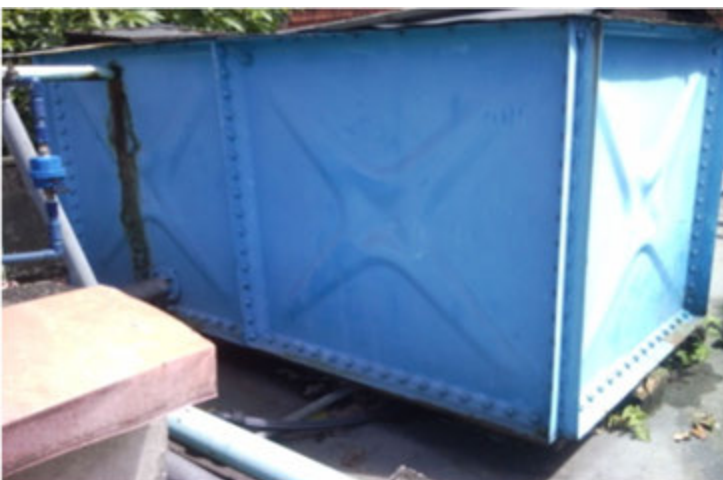
Photo 5
Smaller water tank view

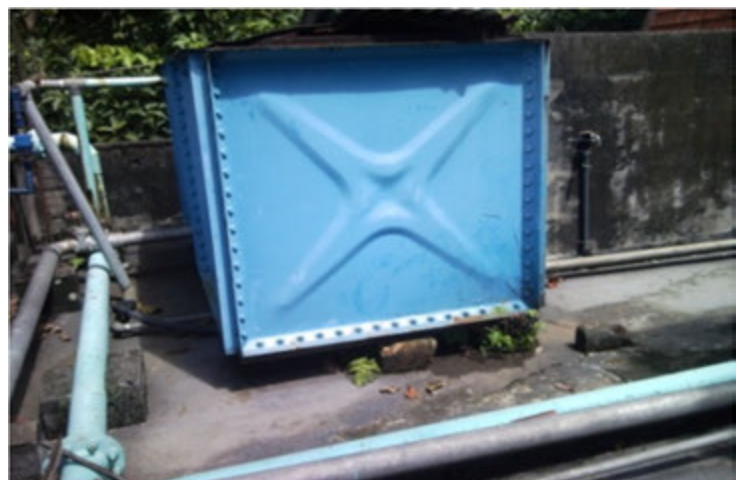
Photo 6
Another view of smaller water tank corroded view

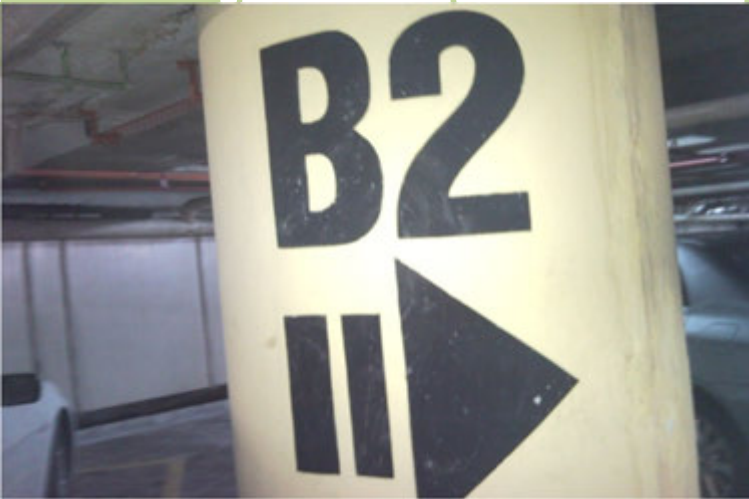
Photo 1
Car park basement B2 m/s c. l. pipes leakage

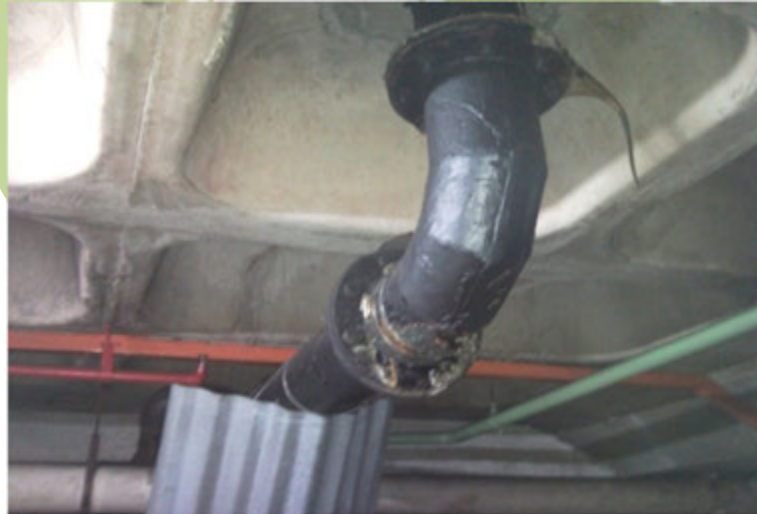
Photo 2
Existing elbow shape leakage / defective at double front fitting view

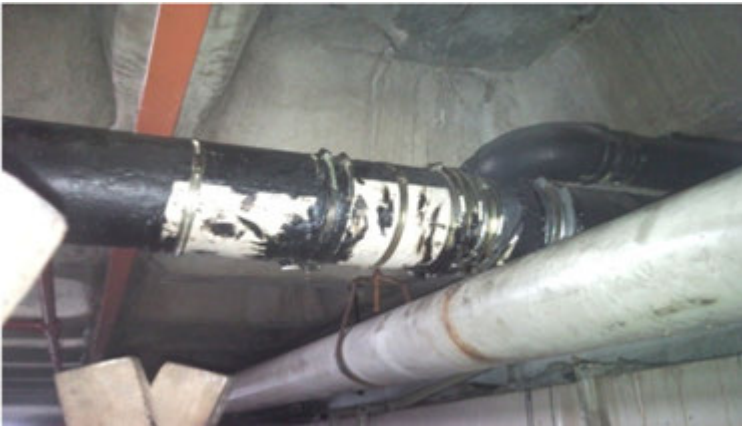
Photo 3
Side view of c.l. piping leakage at car park B2 area

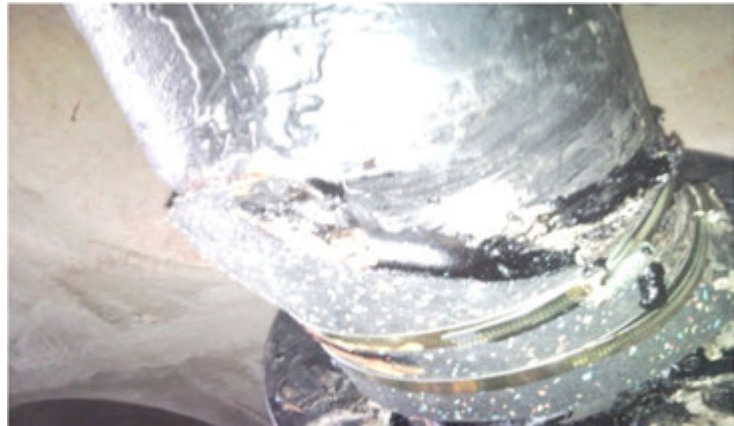
Photo 4
Another view of existing leakage c.l. pipes view at car park B2 area.

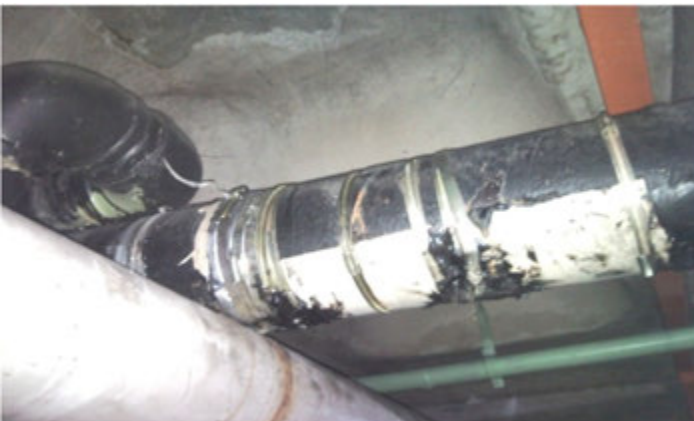
Photo 5
Another view of existing leakage c.l. pipes view at car park B2 area.

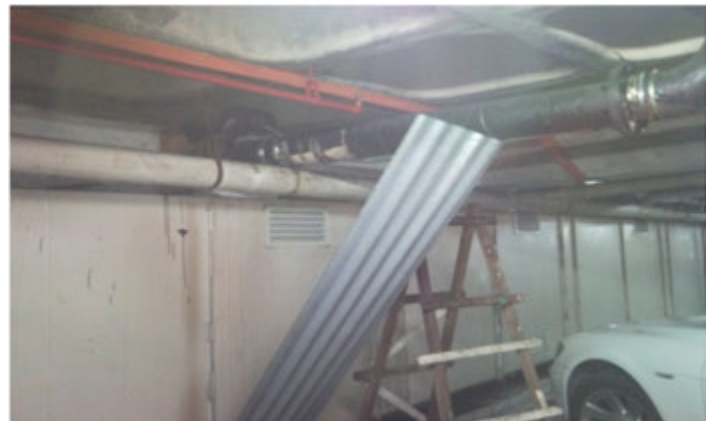
Photo 6
Front view of leakage piping
