**BUILDING SOLUTION SYSTEM**

**Basement**

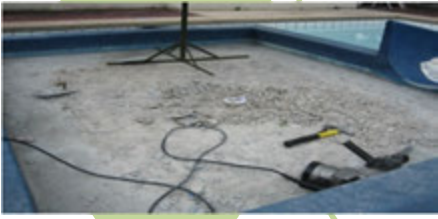
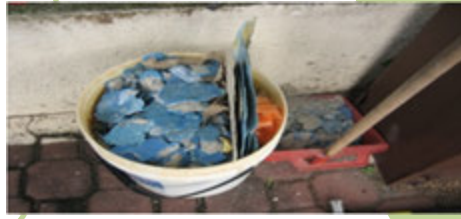
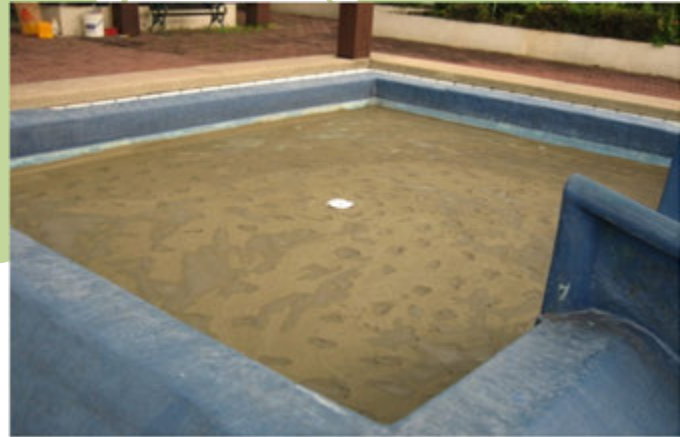
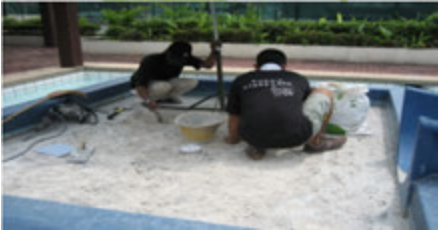
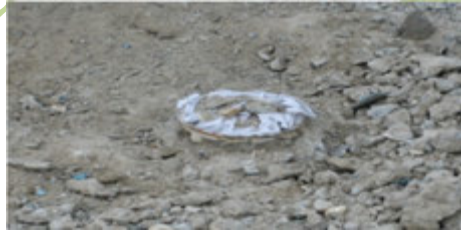
ABOVE SITE PHOTO 1  
Removal of interior defective baby pool surface area and clear off site in progress...

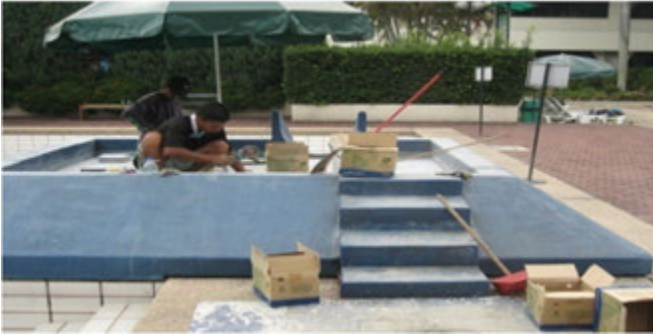
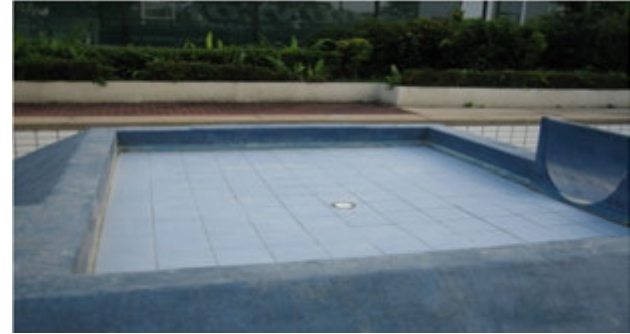
ABOVE SITE PHOTO 3  
Installation of new tiling at baby pool surface in progress...

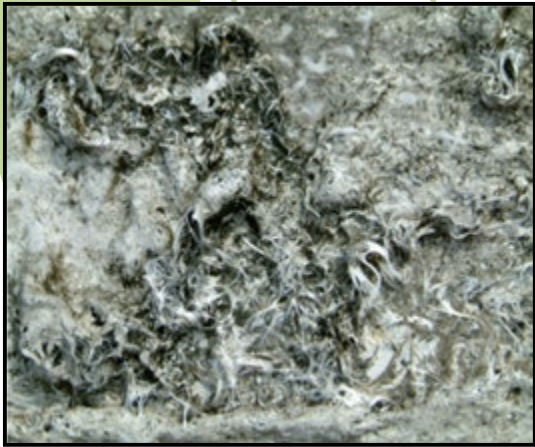
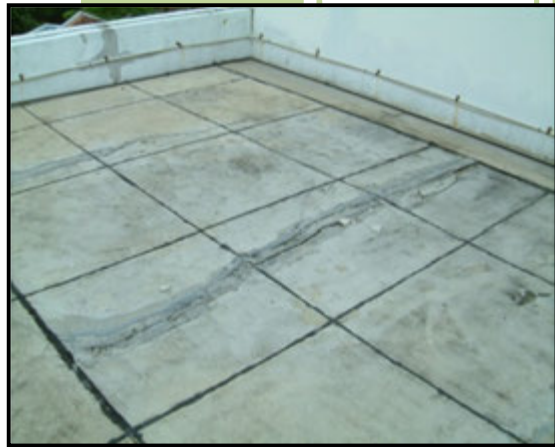
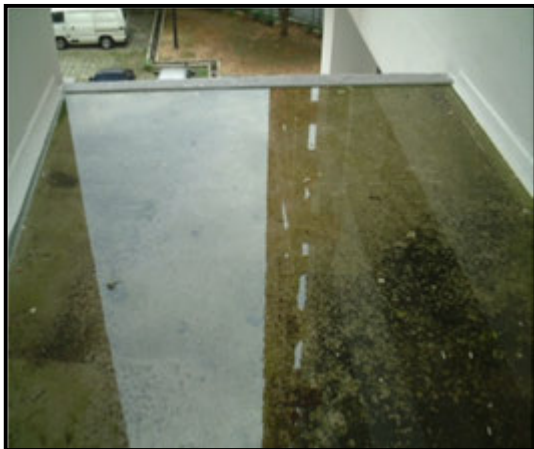
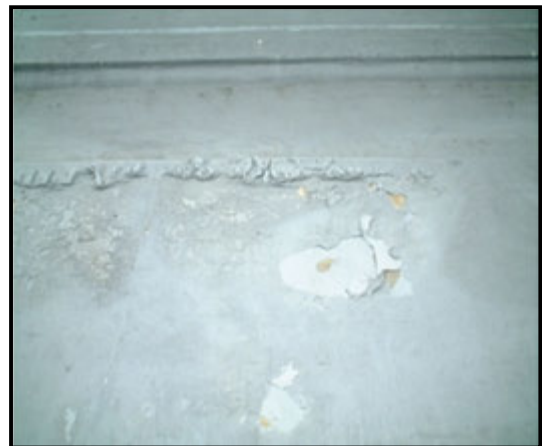
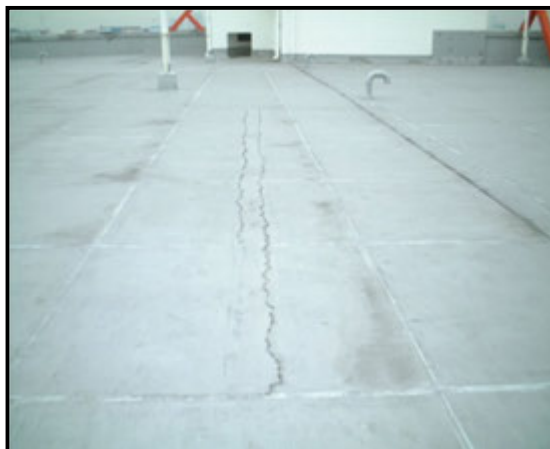
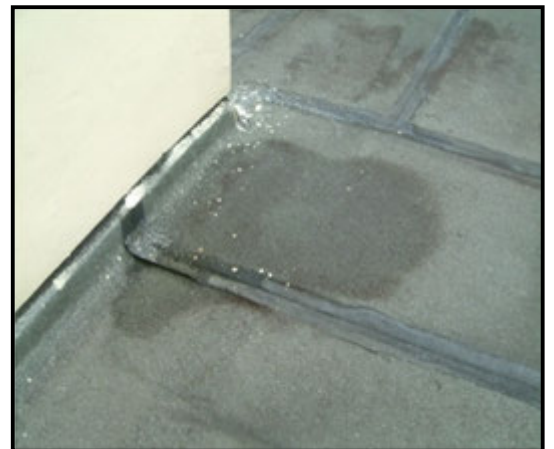
## RIGHT WAY INDUSTRIAL (MALAYSIA ) SDN BHD – DEFECTIVE METAL ROOF AT BLOCK G & H, R.C. ROOF AT BLOCK A EXISTING SITE CONDITION

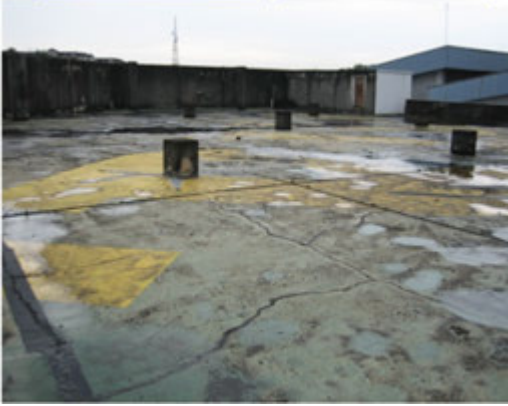
PHOTO 1  
Top view of defective R.C. flat roof at  
block A office area

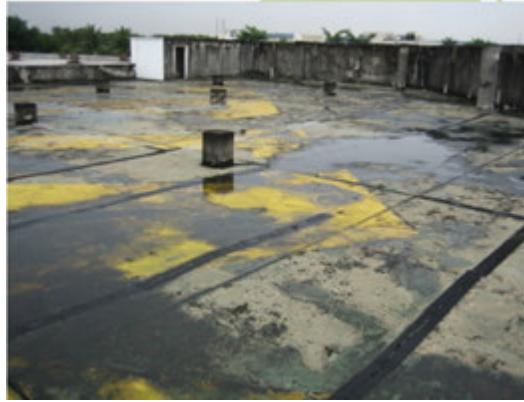
PHOTO 2  
R.C. flat roof water ponding view

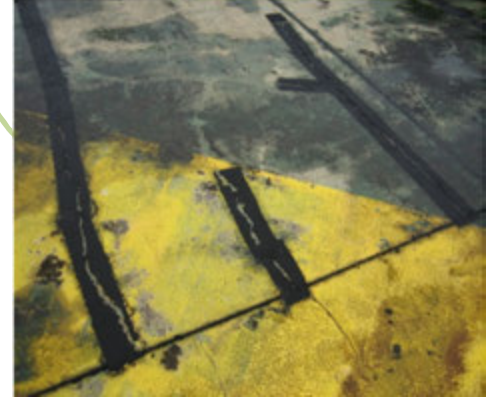
PHOTO 3  
Cracked and defective R.C. flat roof  
view.

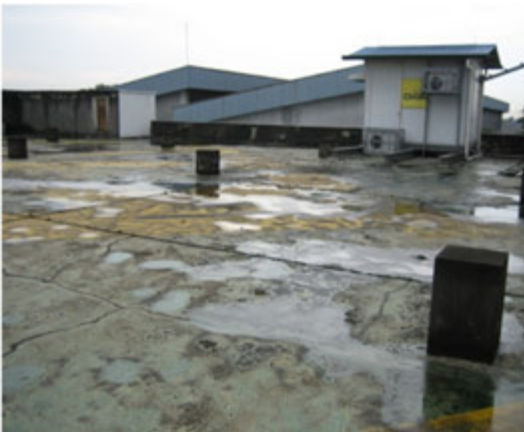
PHOTO 4  
Water ponding and defective R.C. flat  
roof view.

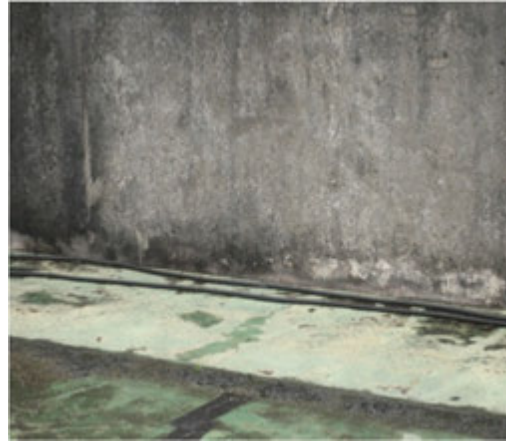
PHOTO 5  
Another view of defective R.C. flat roof  
and parapet.

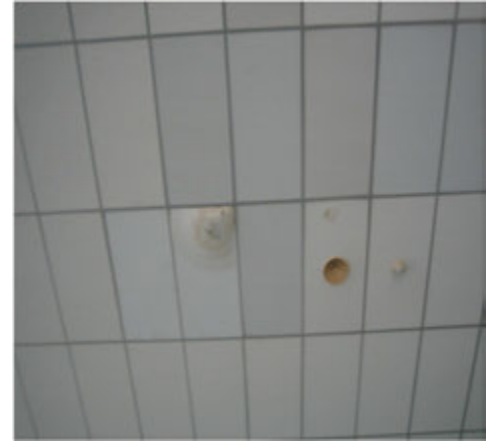
PHOTO 6  
Water stained mark at ceiling board  
from roof top view.

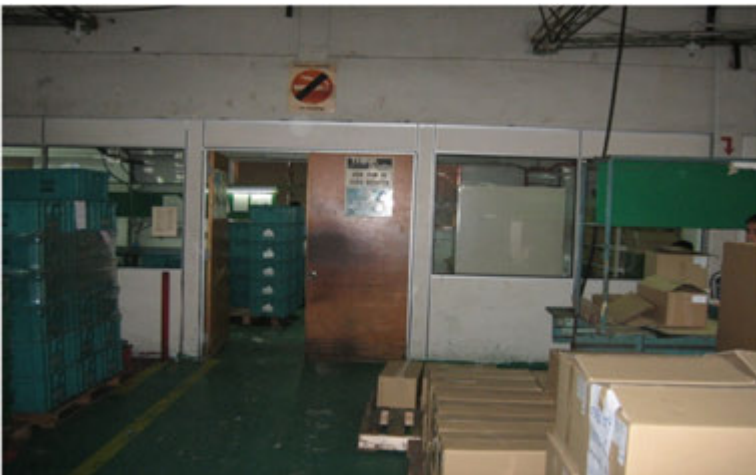
PHOTO 7  
Existing inspection room required extension proposal

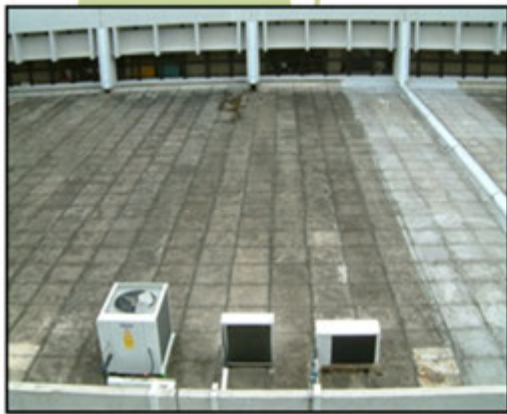
1. Existing old RC roof condition.

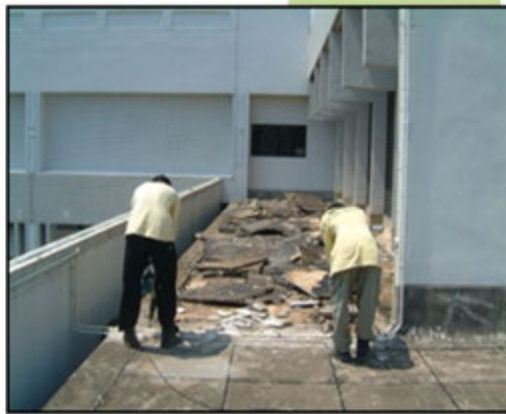
2. Hacking of existing panel, insulation board, separation layer and existing waterproofing membrane.

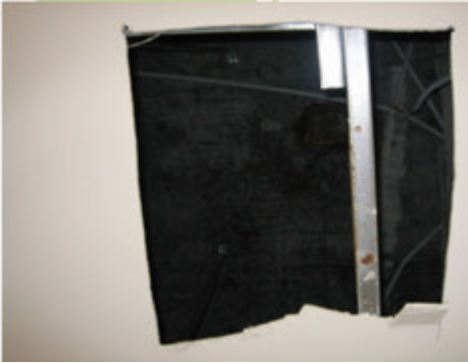
WORK-IN- PROGRESS AT 2 LOCATIONS WATER LEAKAGE SPOTS.

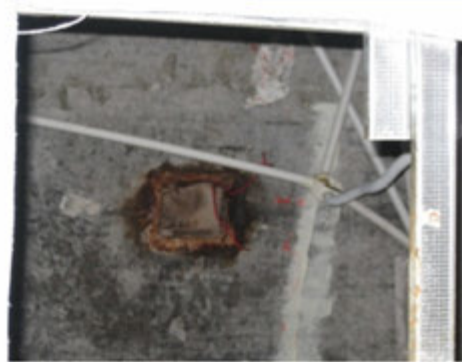
b. Leakage spot can be seen at opening soffit area.

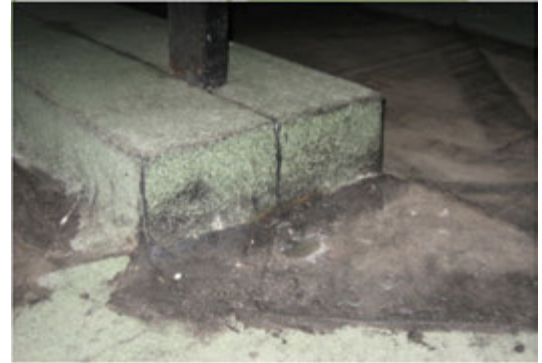
c. survey inspection at roof top to locate the opening soffit in progress....

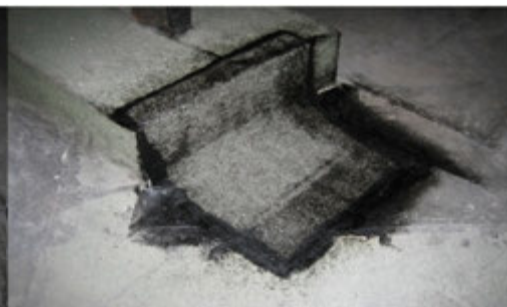
m. After curing, to replace a new membrane at the localise repair and make good.

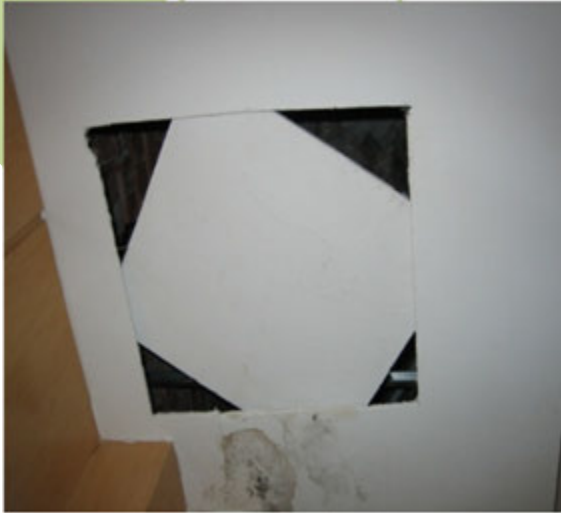
a. 7th Floor Spine & Joint Centre another water seepage stained problem at location 2

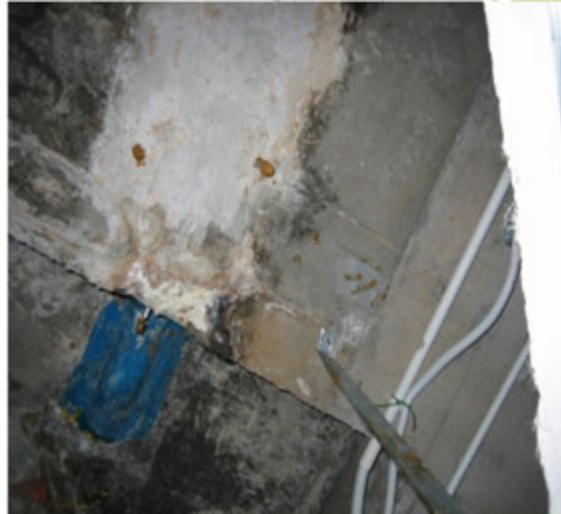
b. leaking location view at location 2

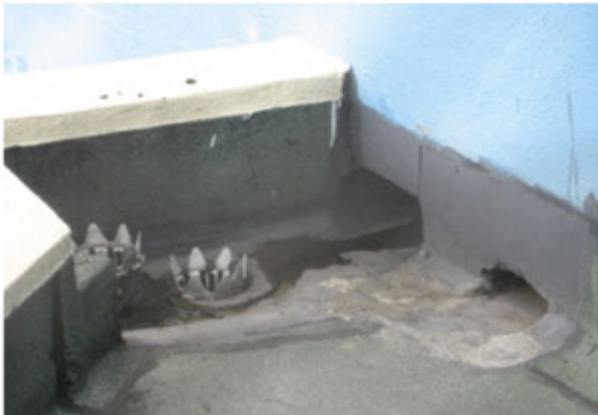
d. Another view of scupper drain defective causing below Spine & Joint Centre water seepage problem

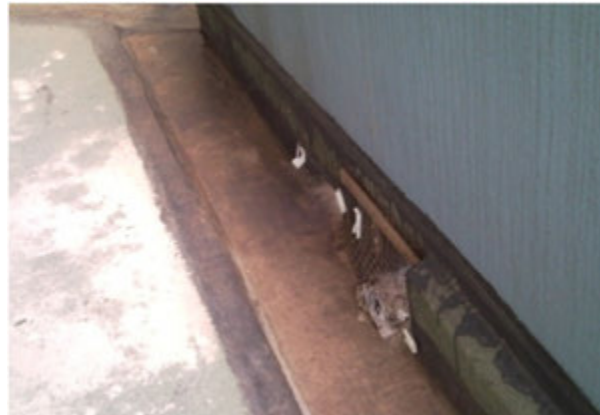
c. Defective scupper drain, causing leakage to below Spine & Joint Center.

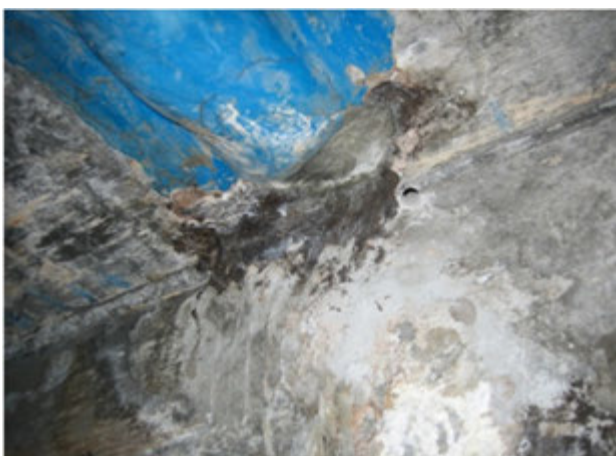
e. Application of high strength epoxy putty to seal the leaking spot.

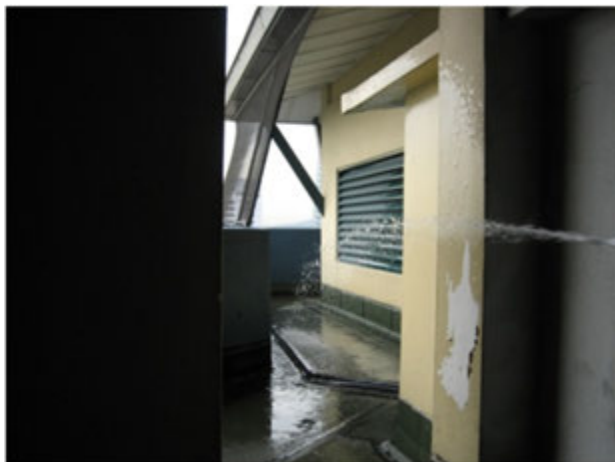
f. After completion the treated area, thereafter to conduct water testing at site. Result OK.

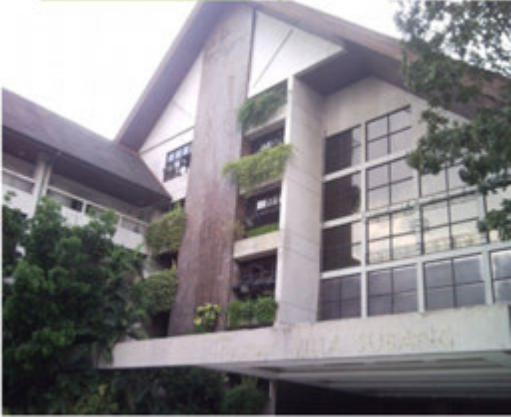
PHOTO 1  
Front entrance at Holiday Villa Hotel & Resorts Subang View

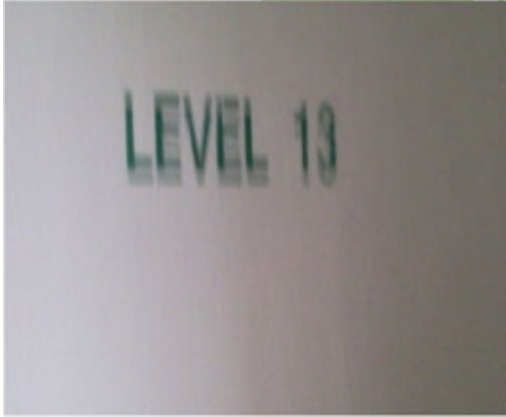
PHOTO 2  
Level 13 tower block to room RC slab leakage

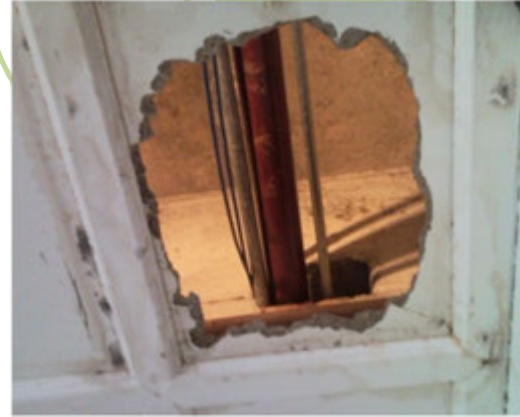
PHOTO 3  
Level 13 room entrance above RC slab leakage to below ceiling board view

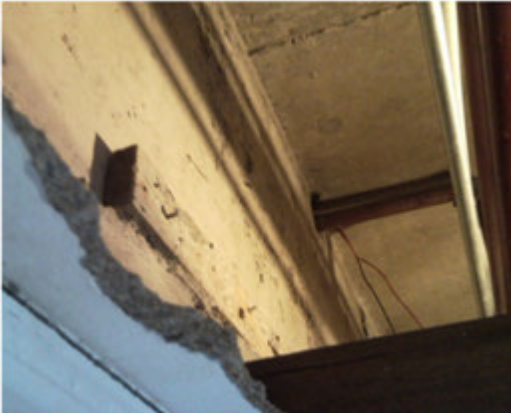
PHOTO 4  
Level 13 room entrance RC slab leakage and causing below stained

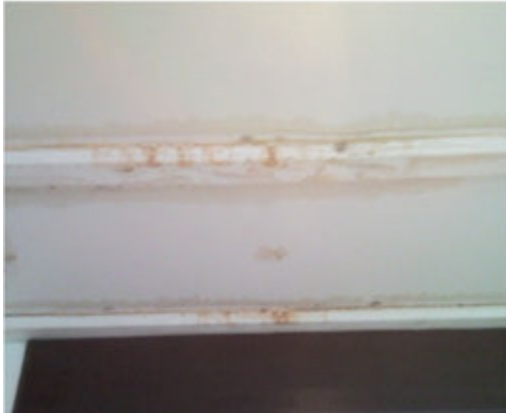
PHOTO 5  
Room entrance door frame ceiling board water stained view

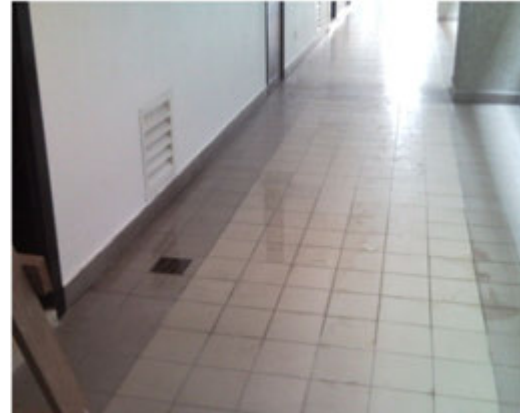
PHOTO 6  
Room entrance floor water stained due to leakage from above RC slab

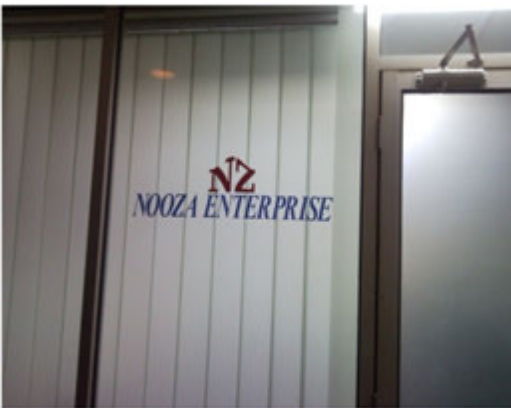
PHOTO 7  
Another location at NOOZA ENTERPRISE office water stained view

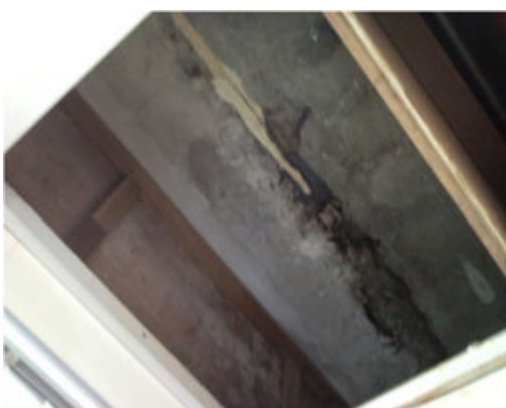
PHOTO 8  
NZ office RC slab leakage view

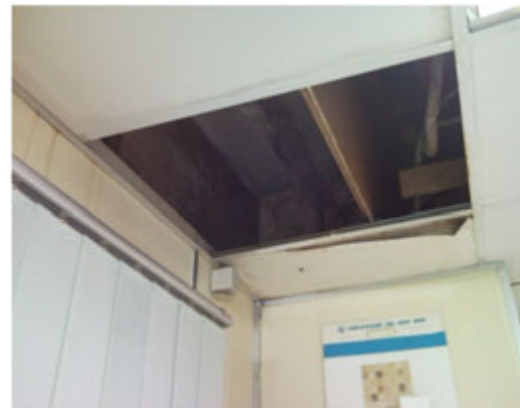
PHOTO 9  
Another view of NZ RC slab stained view

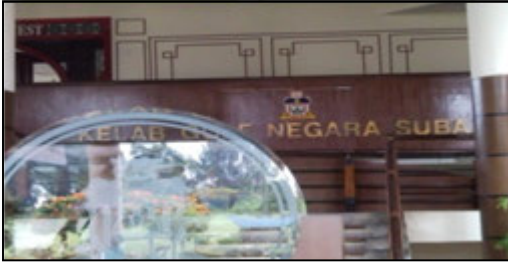
Photo 1  
Kelab Golf Negara Subang entrance to Japanese Restaurant roof leakage..

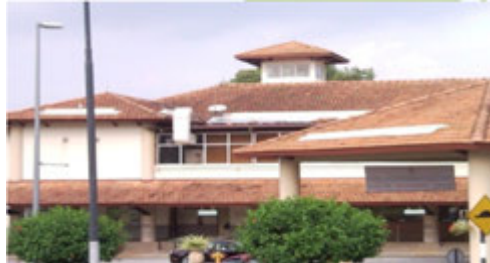
Photo 2  
Existing external tile and metal roof leakage view

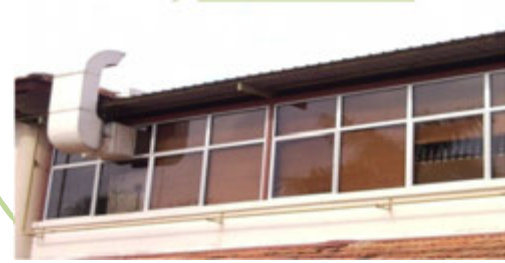
Photo 3  
Another view of metal roof front elevation where leakage from metal roof top

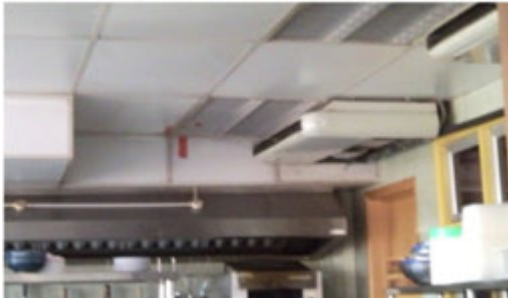
Photo 4  
Japanese restaurant kitchen area leakage from above metal roof

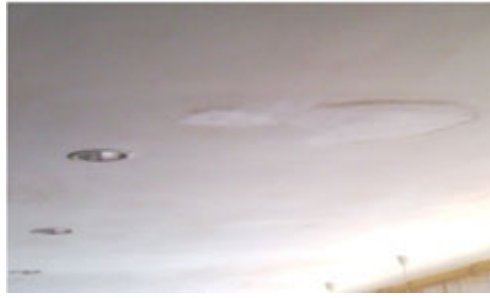
Photo 5  
interior ceiling stained due to leakage from above metal roof..

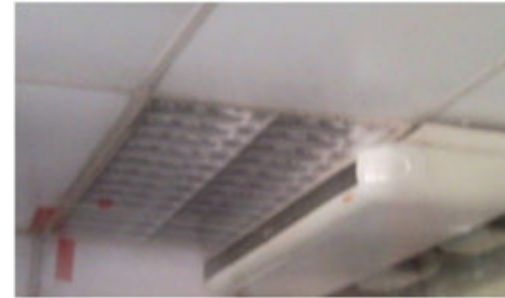
Photo 6  
Another view of ceiling stained

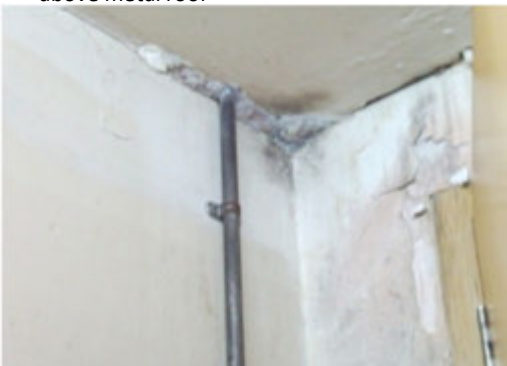
Photo 8  
Interior kitchen area water stained from above metal roof. Flashing not cover to the extended valley and joint area between

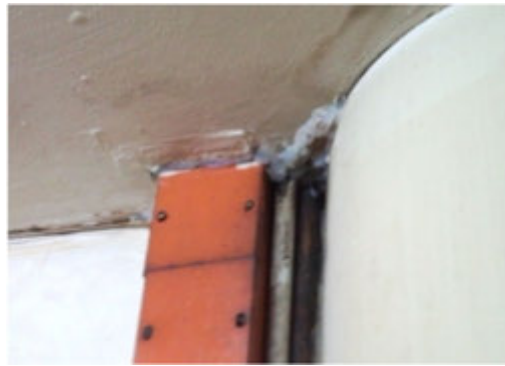
Photo 7  
Kitchen area stained ceiling and wall area due to leakage from above metal roof

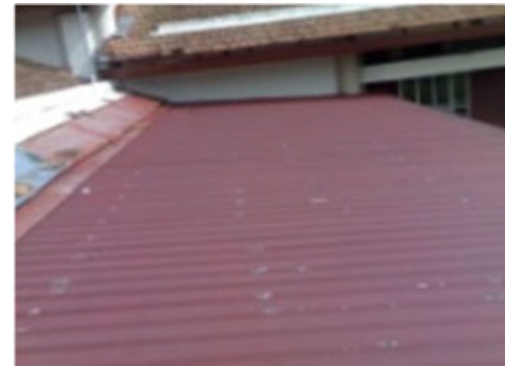
Photo 9  
Metal roof top view of defective flashing between tile roof and metal roof joint..

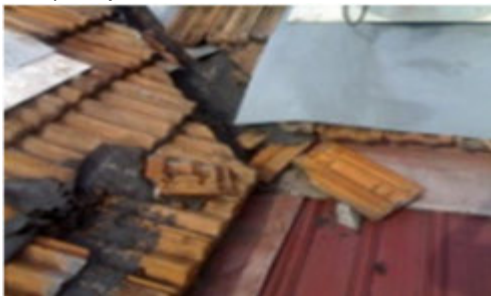
Photo 10  
Top view of defective tile and valley area causing heavy rain water back flow to ceiling area....

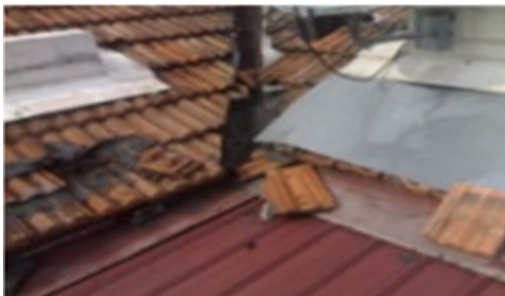
Photo 11  
Flashing not cover to the extended valley and joint area between tile and metal roof and defective sealant to be treated to avoid water backflow

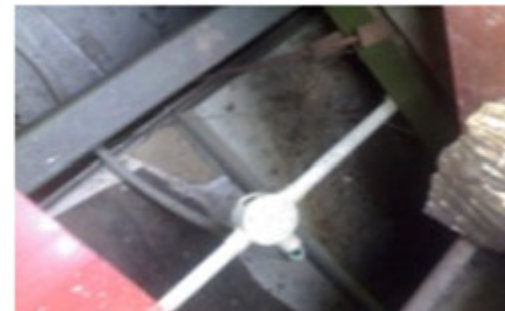
Photo 12  
Metal roof leakage to below Japanese Restaurant view
